NONDESTRUCTIVE EVALUATION AND ENDURANCE TESTING OF REFURBISHED T53 ENGINE BEARINGS P/N 1-300-015-(02/04)

FINAL REPORT SwRI Project 17-5607-821/822

Prepared for
U.S. Army Aviation Systems Command
St. Louis, Missouri 63120

December 1987

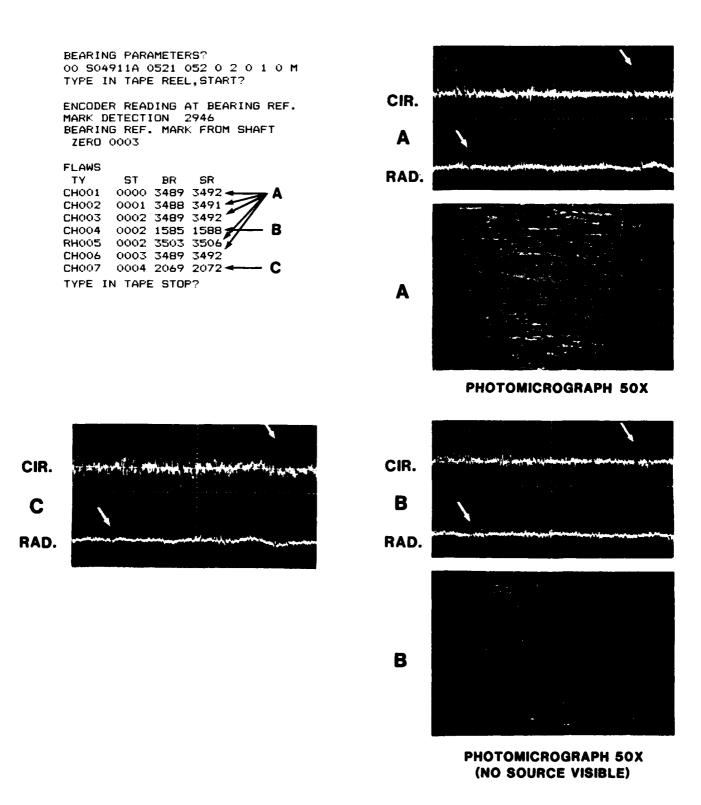
Figure 6: Magnetic Perturbation Inspection Results for Inner Race (S04911A)

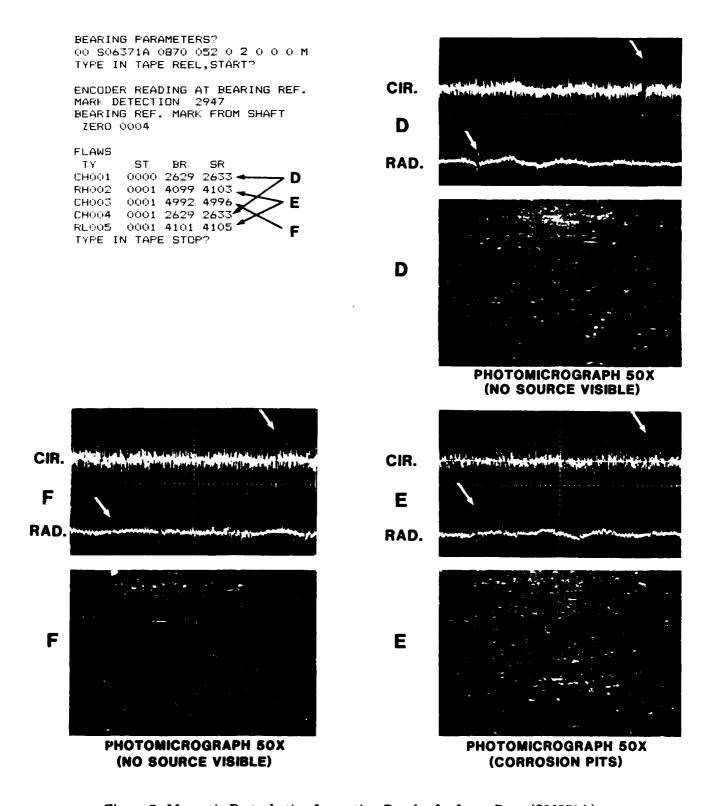
Figure 7: Magnetic Perturbation Inspection Results for Inner Race (S06371A)

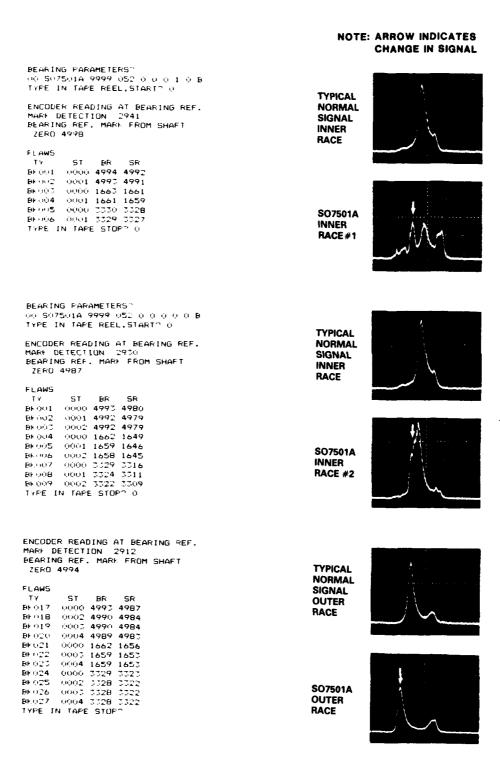
Figure 8: Barkhausen Signal Analysis Results for Bearing (S07501A)

5. Comparing the results of the Barkhausen stress indicator is difficult in that only a small percentage of the original races showed indications of abnormal stresses. A comparison of the results before and after regrind indicates that the number of races with non-uniform stresses was reduced significantly from 28 races to 4 races. One bearing, SwRI I.D. S07501, had abnormal Barkhausen signatures before regrinding as shown in Figure 8. This bearing also produced abnormal Barkhausen signals after regrinding. Since all three races (2 inner halves and 1 outer) produced abnormal responses, the most likely cause for these changes in residual stress is overheating. Hardness testing revealed all three races of this bearing had hardness of less than R_c50 as compared to the specified hardness of R_c60 to R_c62. This overall softening of the steel could not be corrected by regrinding. This bearing was included in endurance test No. 17 and failed early at 73.4 hours.

- 5. Residual stress changes in bearing (S07501), which were detected by the Barkhausen Noise Analysis method, were not removed by regrinding. This race failed early during endurance testing. It is concluded that regrinding does not guarantee that races with residual stress changes will be restored to the original condition.

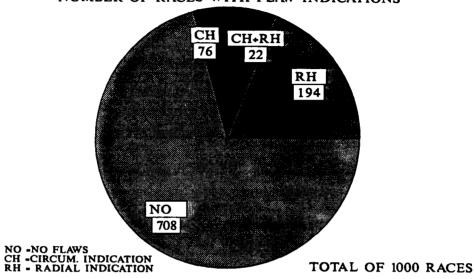
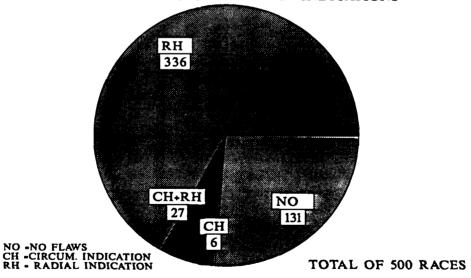
Figure 9 shows the number of races with each type of magnetic perturbation high field inspection results. Races with CH signals have flaws which are most likely subsurface while races with both CH and RH indications have surface flaws which have some depth. One important result shown in this figure is that 530 races (inner and outer) have only Magnetic Perturbation Radial signals which indicate only superficial surface damage or minor corrosion. The visual inspections of these races confirm these results. These races could have been refurbished by a light honing process or polishing. Out of the 1500 races inspected, an additional 811 had no detectable flaws for a total of 1341 races leaving only 159 races with flaws that may be removed by regrinding. Of this group of 159 races, 82 have only magnetic perturbation circumferential signals. This is significant because any flaw detected by the circumferential inspection but not detected by the radial inspection is subsurface. Regrinding may not remove such flaws and may only expose the flaw to the surface making the race more likely to fail. This leaves only 77 races which would most likely benefit from regrinding.

Figure 9: Pie Charts Showing the Number of Races with Magnetic Perturbation Flaw Indications

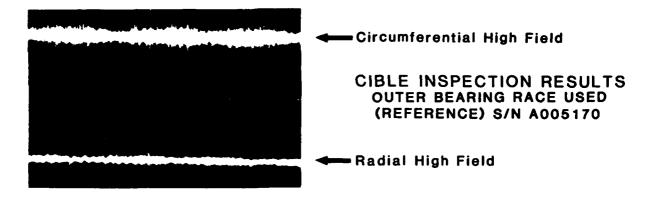
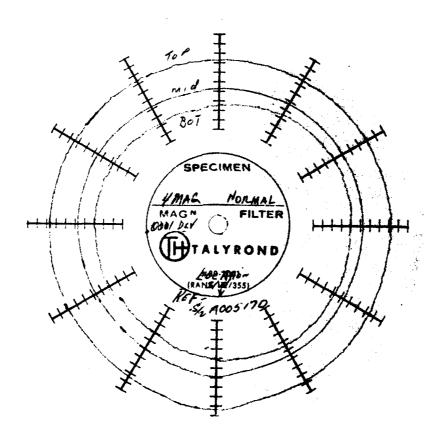
Figure 10: Talyrond Results For The Reference Bearing Which Was Not Reground

Figure 10 is the results for the reference bearing which was not reground. The photograph at the top of the figure shows the circumferential high field magnetic perturbation signature and the magnetic perturbation radial high field signature which look normal. The Talyrond trace shows a graph of the deviation from a perfect circle for the outer bearing race as measured at three locations across the ball groove. These results are typical of a good bearing.

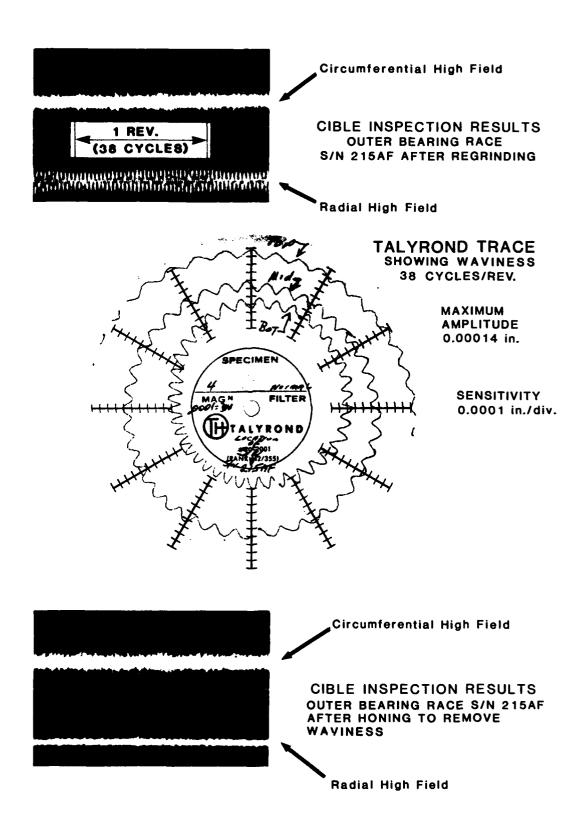
Figure 11 shows the results of a reground bearing which was received in the first 50 bearings. The photograph at the top of the figure shows the circumferential high field signature and the radial high field signature as recorded during the initial inspection of the reground bearing. Note the high level sinusoidal signal which has a frequency of 38 cycles per revolution. The Talyrond trace in the middle of the figure shows a corresponding sinusoidal signal with a maximum amplitude of .00014 inches. This is an unacceptable amount of waviness for a high speed engine bearing. All 50 of the bearing assemblies were returned to ITI for additional rework. The photograph at the bottom of Figure 11 shows the circumferential high field signature and the radial high field signature after the bearing had been honed at ITI to remove the waviness.

Figure 11: Talyrond Results Of A Reground Bearing Which Was Received In The First 50 Bearings

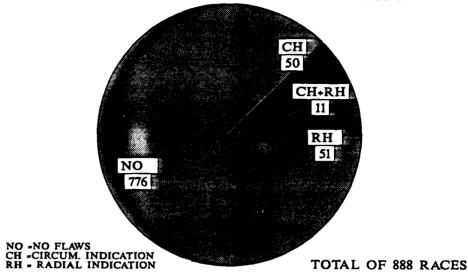
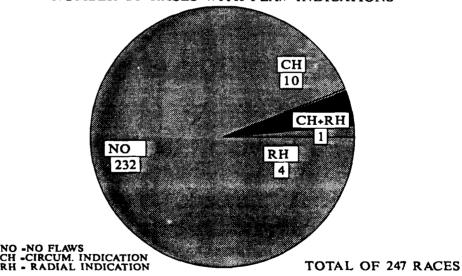
The results of the inspection of these 444 bearings after refurbishing produced some interesting results. These results are shown in the pie charts in Figure 13. By doing a comparison of the number of flaws detected by each type of inspection utilized in the CIBLE system, the following observations can be made:

- 2. Making a comparison of races which had CH + RH signals before and after regrind shows a significant decrease in the number of races in this category. Both CH and RH signals from the same location indicate a flaw of significant size and is at the surface or near surface. This type of flaw is usually a scratch, inclusion, or corrosion. These results show that regrinding reduced the number of races with this type of flaw significantly but inspection after regrind should be performed to insure the flaws have been entirely removed.

- 3. A comparison of bearings which had only RH signals before and after regrind shows a very large decrease in the number of races in this category. A RH signal without an accompanying CH signal at the same location indicates a surface flaw which is superficial mechanical damage or very minor corrosion. This type of damage can most likely be removed without grinding by honing or polishing the surface.

Figure 13: Pie Chart Showing The Number Of Races With Magnetic Perturbation Flaw Indications After Regrind

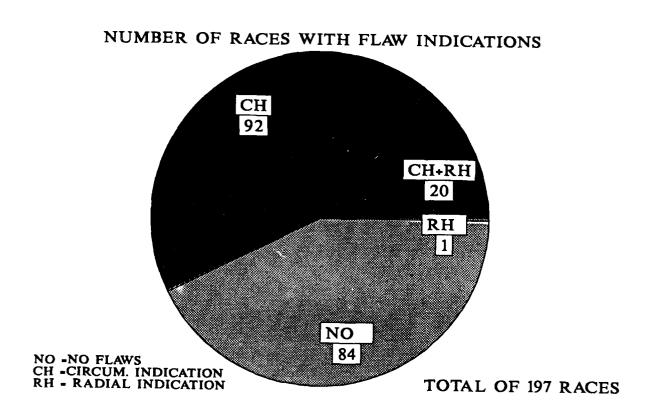
Figure 15: Pie Chart Showing the Number of New Outer Races Manufactured by ITI with Magnetic Perturbation Flaw Indications

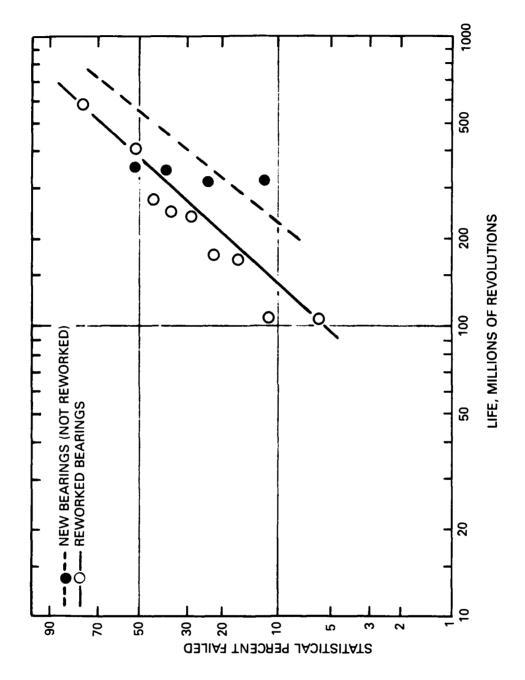
Based on these derived parameters, statistical Wiebull plots of the generated data for both new and reworked bearings, employed in this study, are shown in Figure 18. Since fatigue life for rolling-contact bearings is generally expressed in millions of bearing revolutions, instead of hours or stress cycles, that was employed as the abscissa in this presentation. The new bearings curve (dashed) was significantly influenced by the two bearings that operated for 507 hours (730.1 x 10^6 rev.) without failure. When these two long-duration censored samples were taken into account in the statistical solution, the shape parameter, β , was changed considerably which produced the dashed curve as shown in Figure 18. This curve, although it does not exhibit the best fit through the four plotted new bearing failures (solid data points), should better represent a Weibull plot for new bearings like those endurance tested. Numerous tests and bearing failures would be required to improve the accuracy of the curve. As shown the reworked bearings solid curve fits the data points (open circles) much better. This is because there were more reworked bearing failures and no tests that ran considerably longer than any other tests without bearing failure.

Figure 18: Weibull Plots Of Experimental Data For Bearings Tested At 24,000 RPM And 350,000 PSI Maximum Hertz Stress

- 2. Endurance tests on both new and reworked bearings have been performed employing the bearing tester. Based on these tests, for the two particular populations of bearings used, it was found that the new bearings exhibited L₁₀ (minimum life) and L₅₀ (median life) approximately 1.5 times those for the reworked bearings. Also, two of the new bearings ran beyond the limiting 500-hour "shutoff" duration without failure, whereas none of the reworked bearings exhibited this capability. Based on these findings it is concluded that the new bearings have superior endurance capabilities over the reworked bearings.
